ALASKA STATE TROOPERS, A DETACHMENT, F.M.O.I. PORT.
INVESTIGATED BY DFM's Jerry Gentile/Theresa A. Smith DATES INVESTIGATED June 9-10&17, 2000

TITLE OF CASE FIRE -Other Vehicle M/V Columbia State of Alaska Ferry

SUPPLEMENTAL REPORT Written by Deputy Fire Marshal (DFM) Gentile

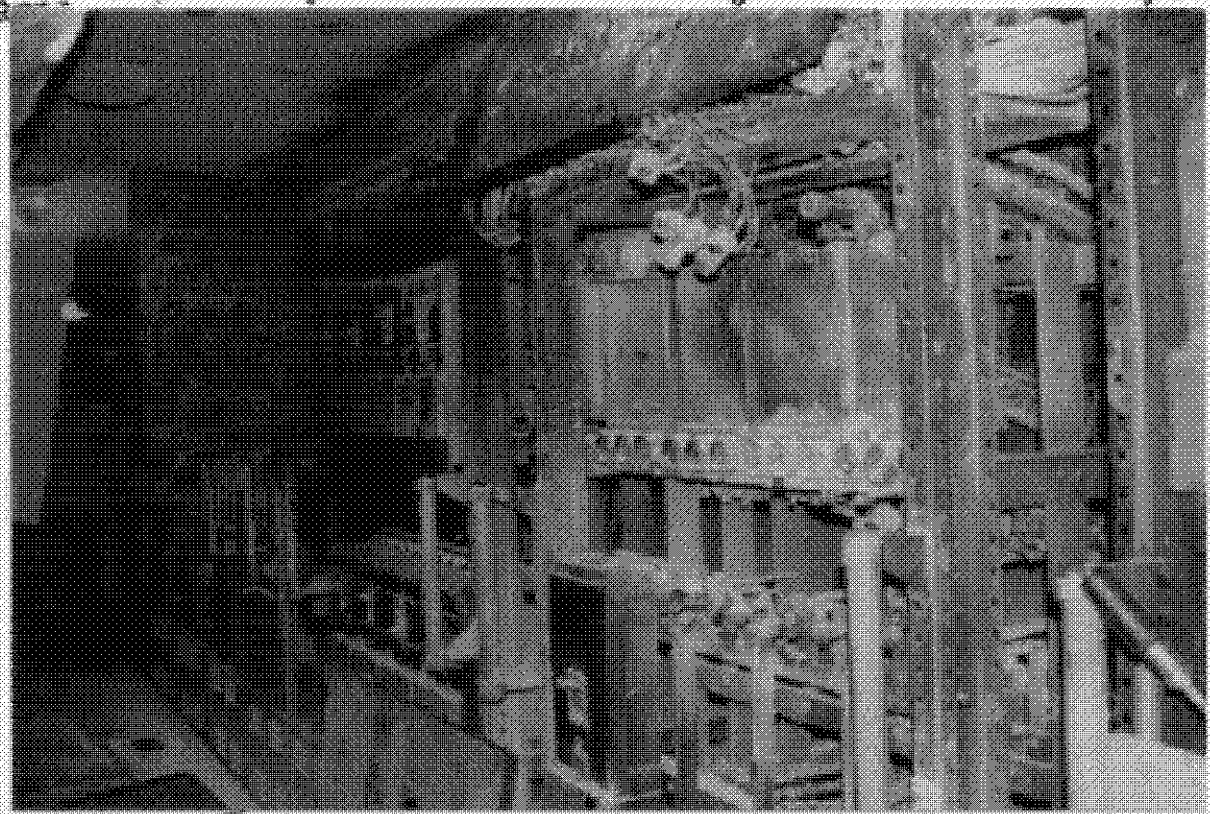
EXPOSURE 5 DEFECTS TOP View of Panels 3, 2, (IX Panels)

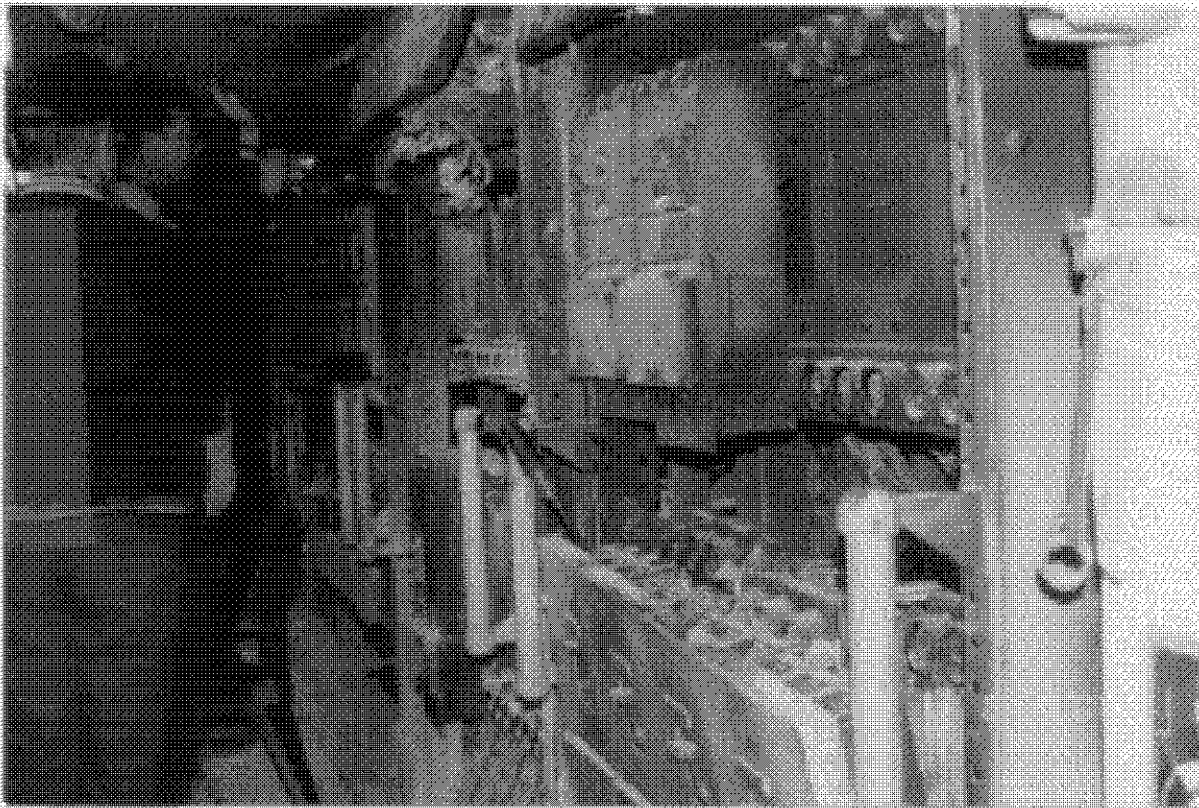
EXPOSURE 9 DEFECTS P-1 + P-2 Showing most damage P-2

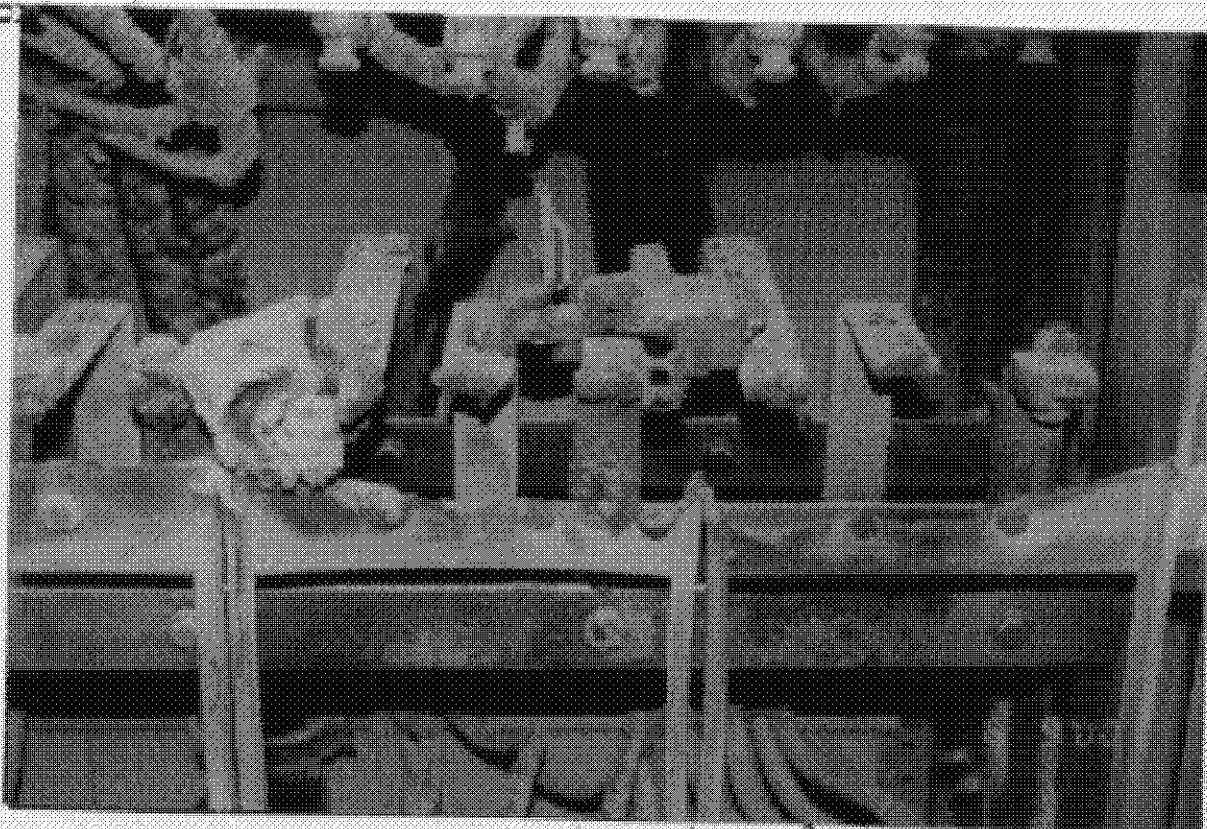
EXPOSURE 11 DEPICTS Lower box P-2

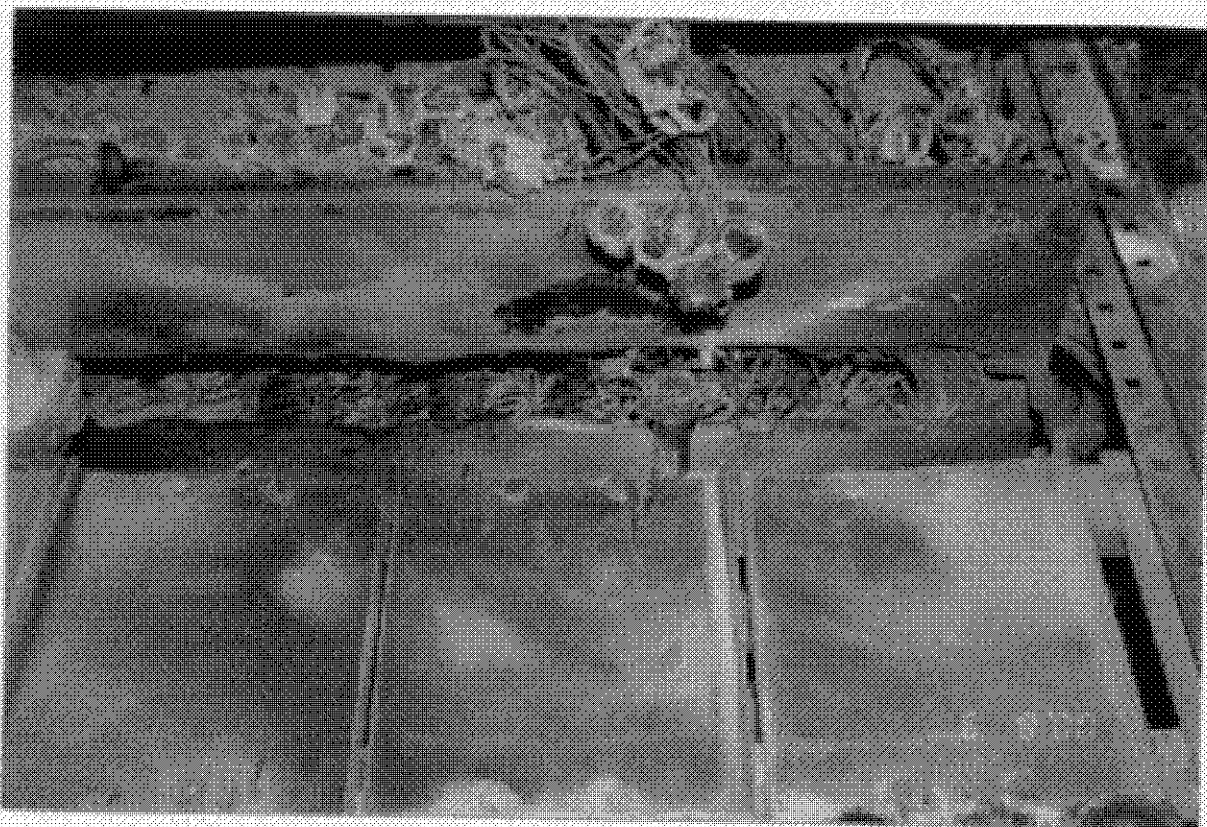
1/8" thick metal tray, which held wires, above panel #2 had a hole burnt through it approx. 6" wide by 3' long in the center of the tray. It was apparent that panel #2 had suffered more heat for a longer period of time than panel #1.

EXPOSURE 12 DEPICTS Top Tray of P-2 showing fire damage

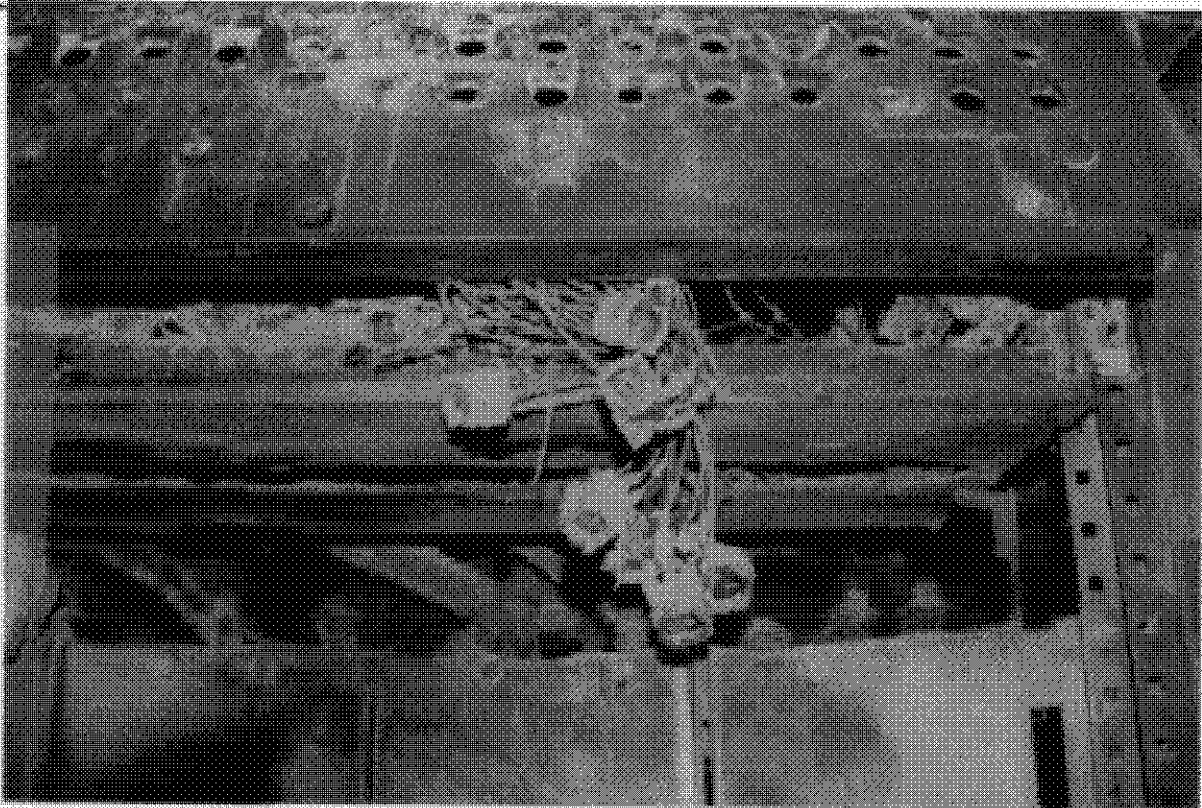
EXPOSURE 16 DEFECTS Top wing body damage & back of door
Panel P-2

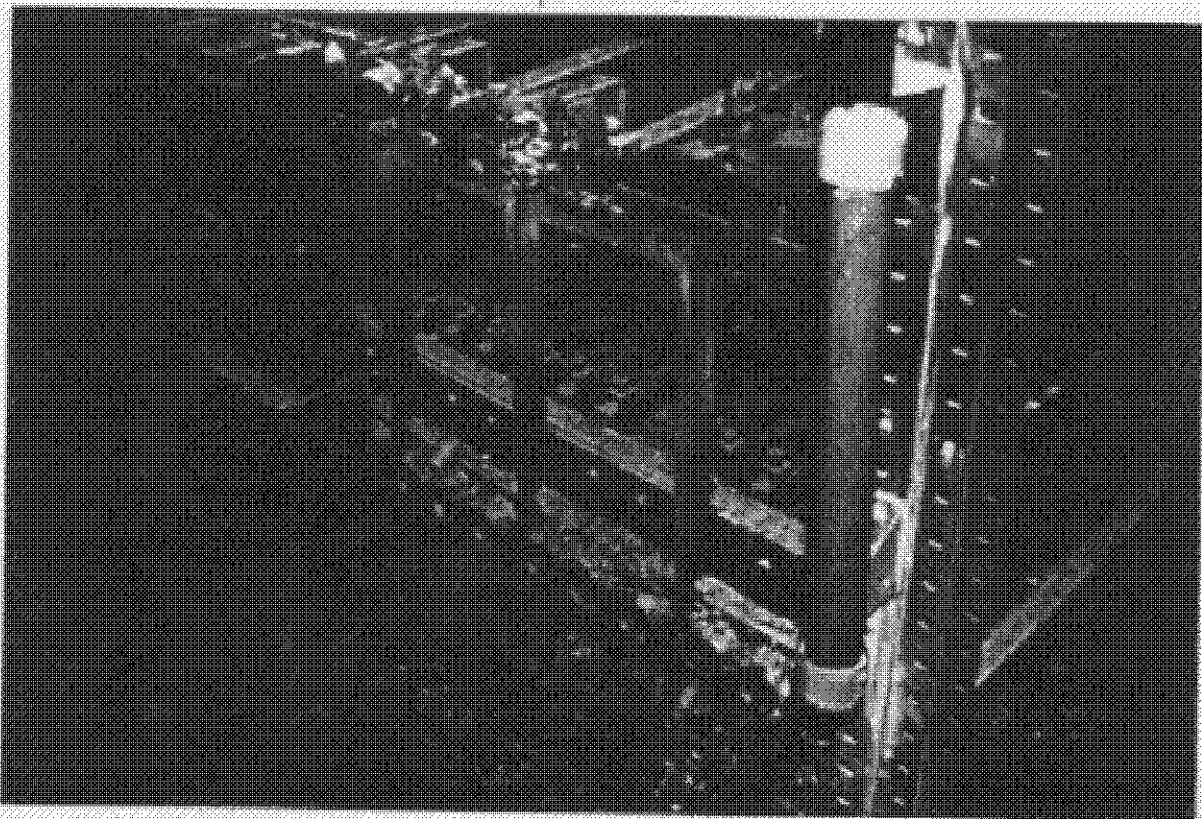
EXPOSURE 19 DEFECTS Lower part of P-2
CASE NAME _____ CASE # _____
LOCATION _____ BY _____

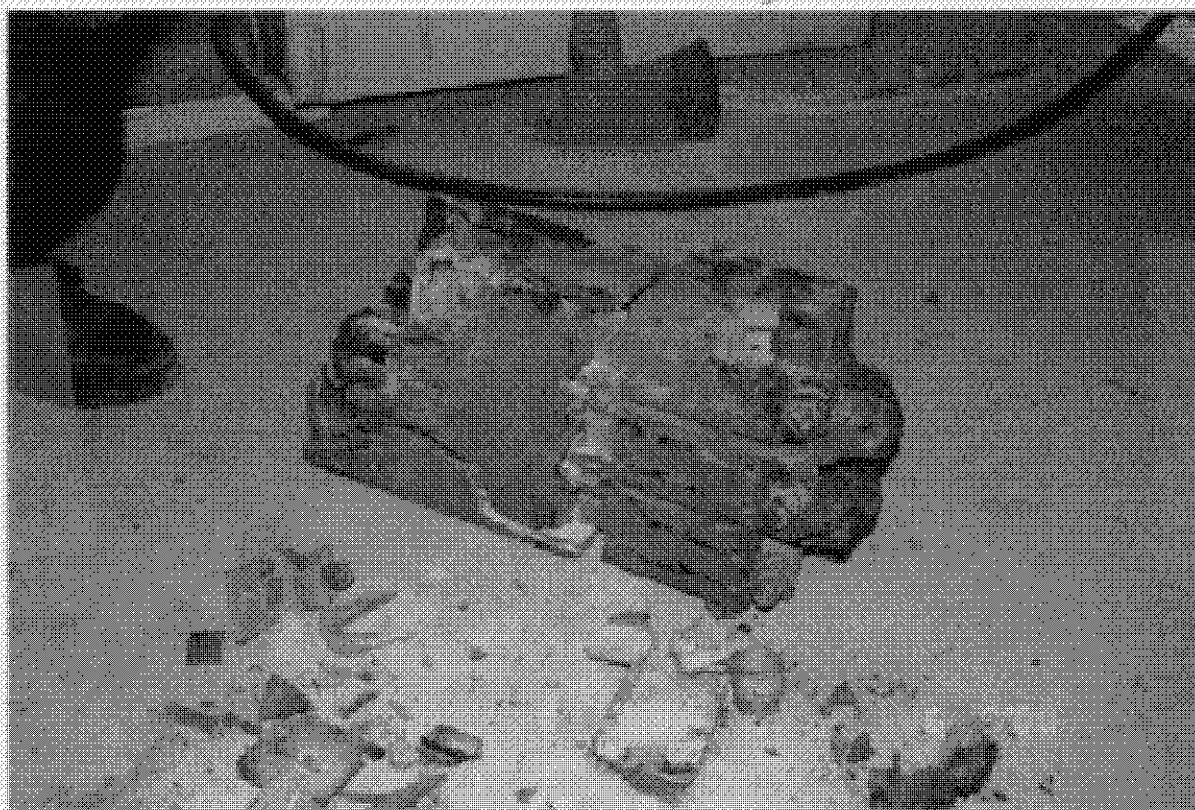
Crater as found outside control room
removed by fire suppression team

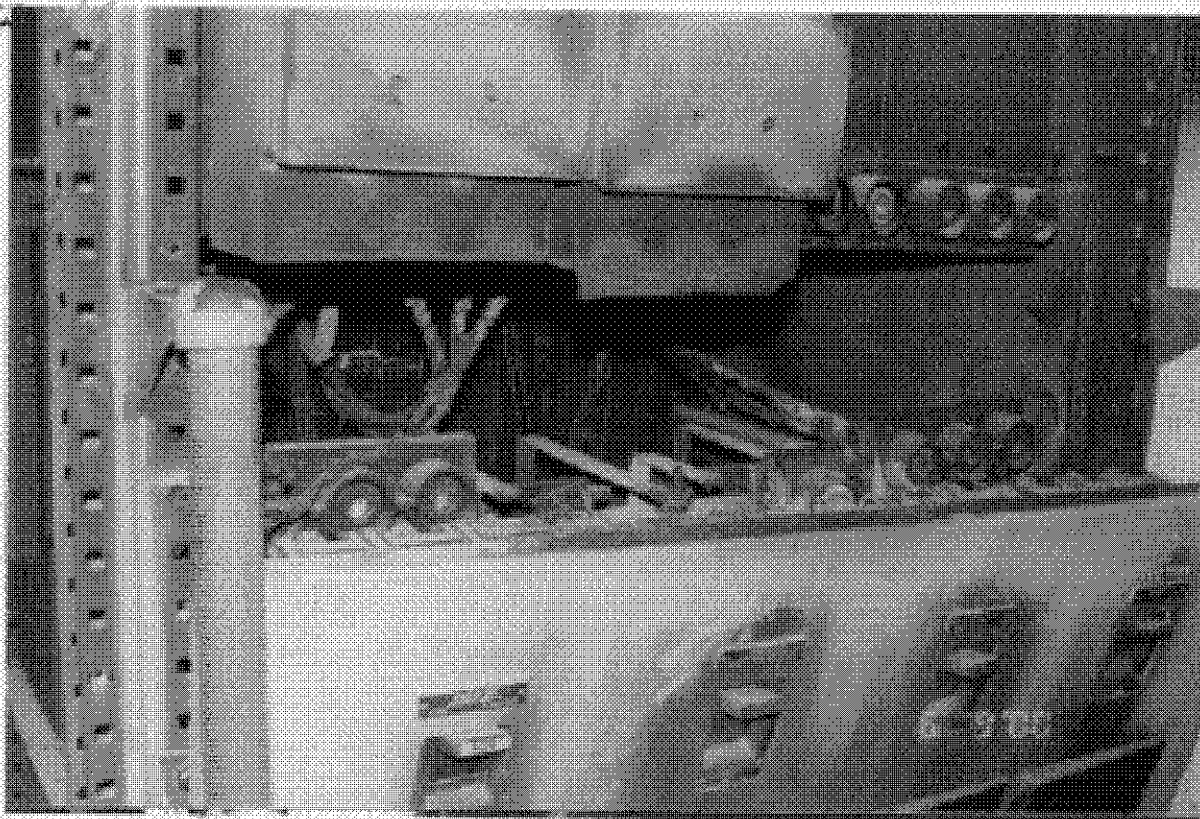
Top of Pt 1 before brackets removed

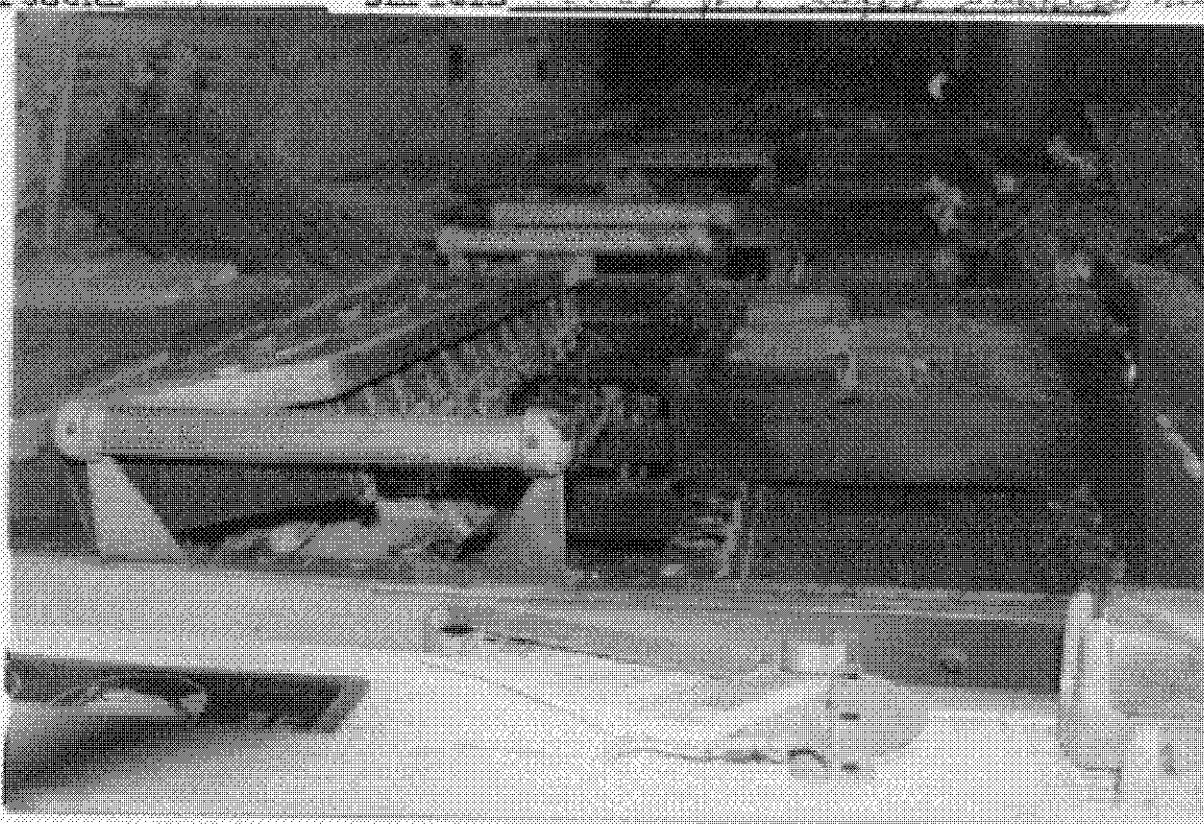
front & inner panels 7-1 - end

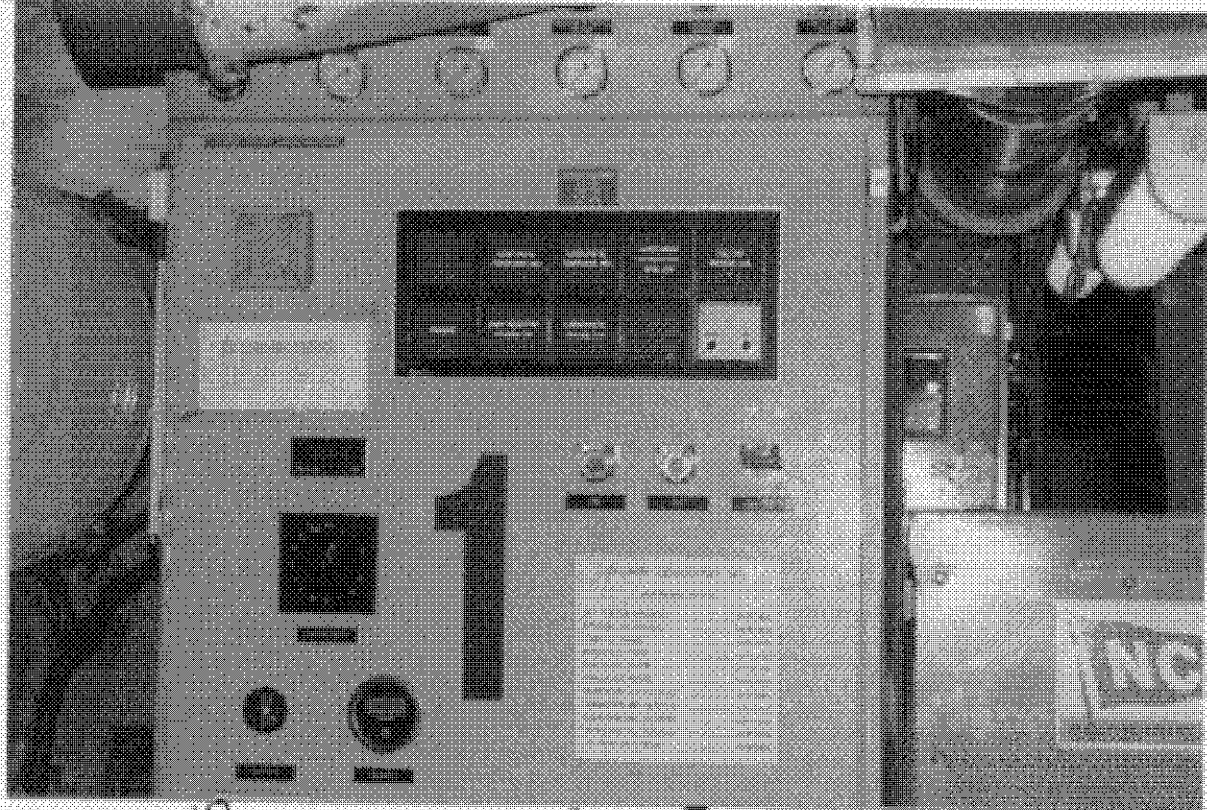
EXPOSURE 18 DEPICTS generator #1 control panel on generator

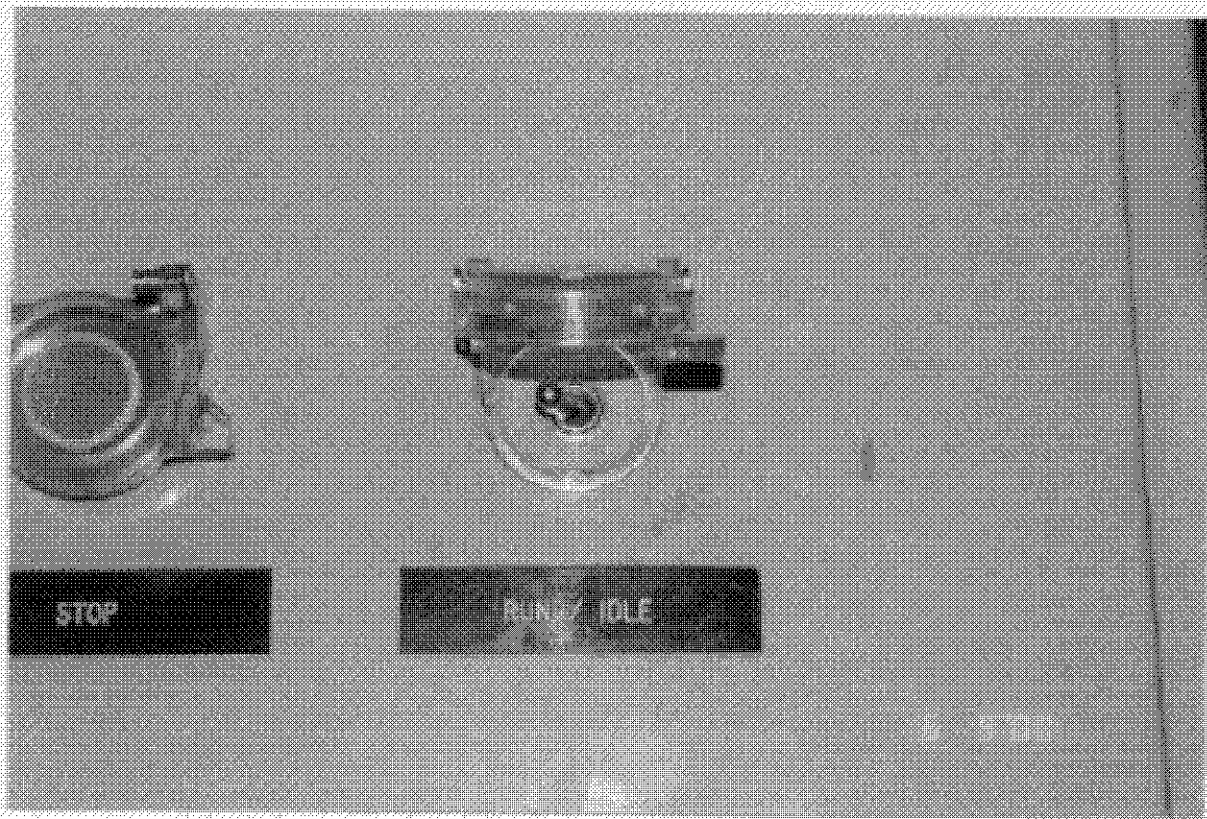
EXPOSURE 17 DEPICTS position of switch on gen #1

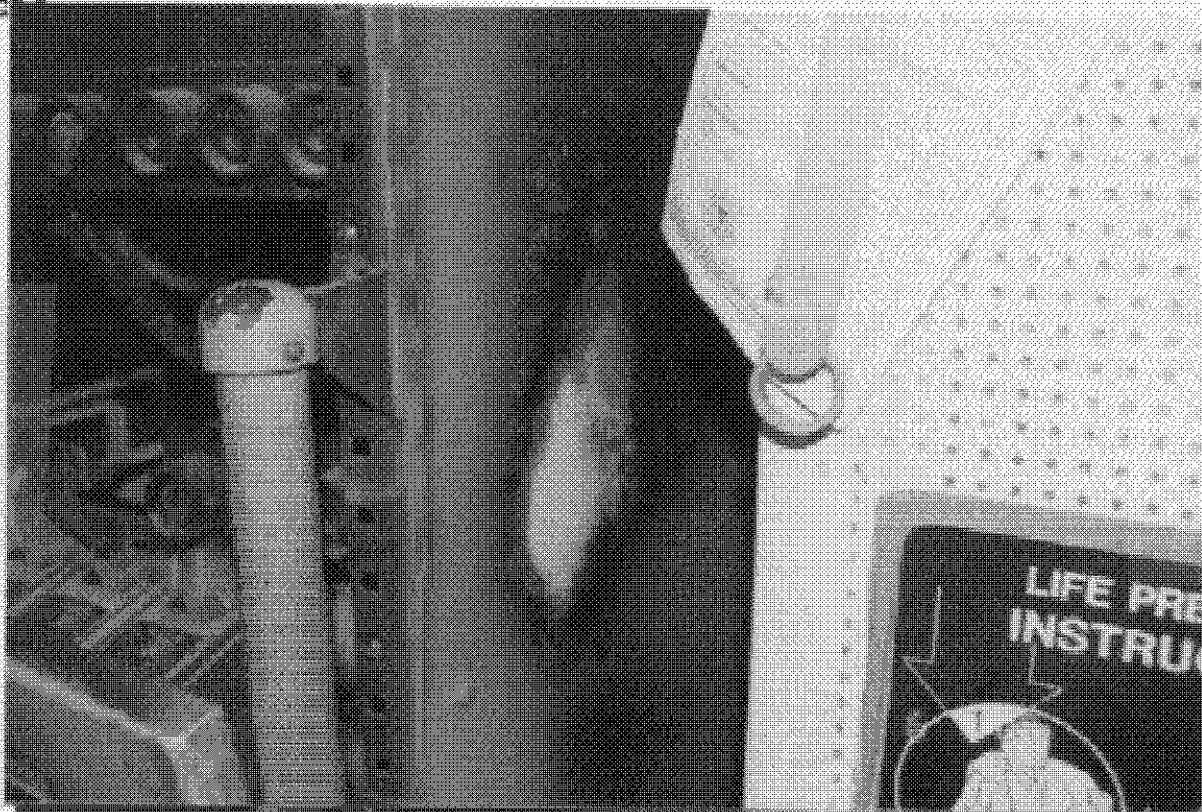
EXPOSURE 21 DEFECTS P-1 far end extension showing
signs of heat

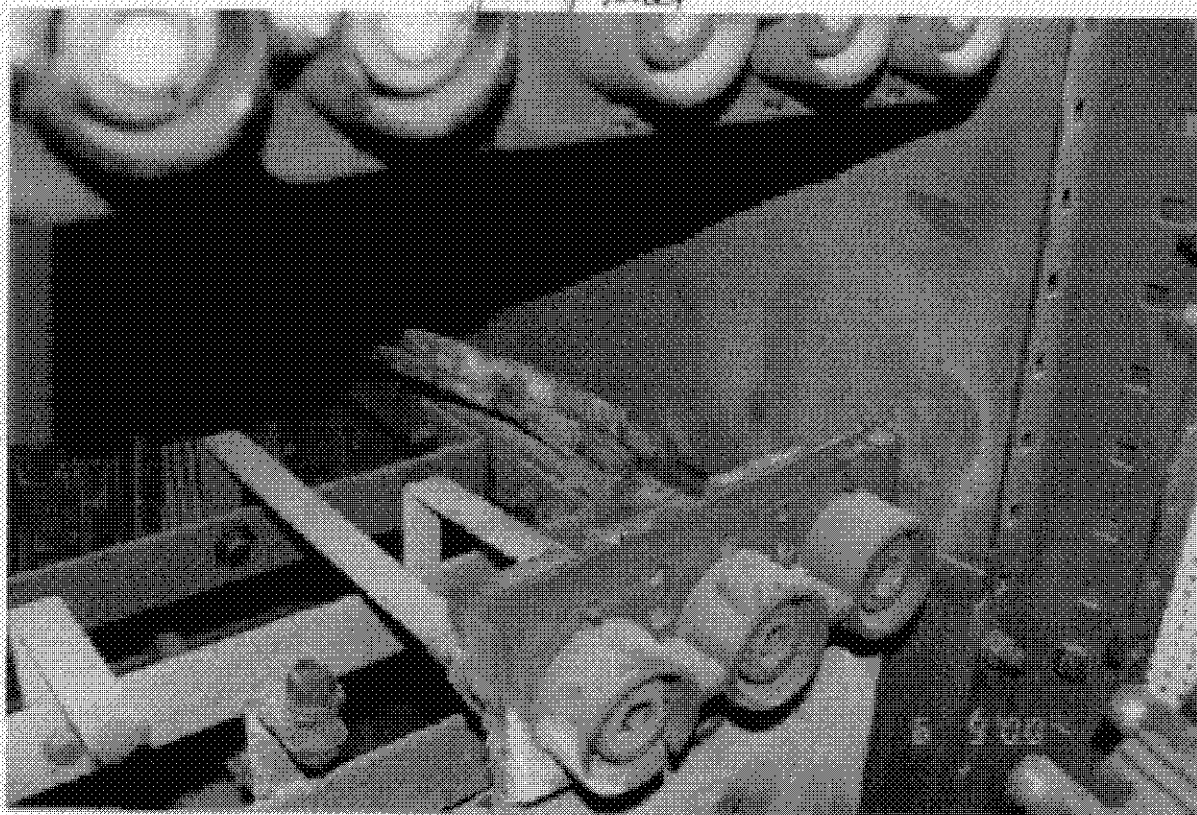
EXPOSURE 22 DEFECTS P-1 inside of above heat mark

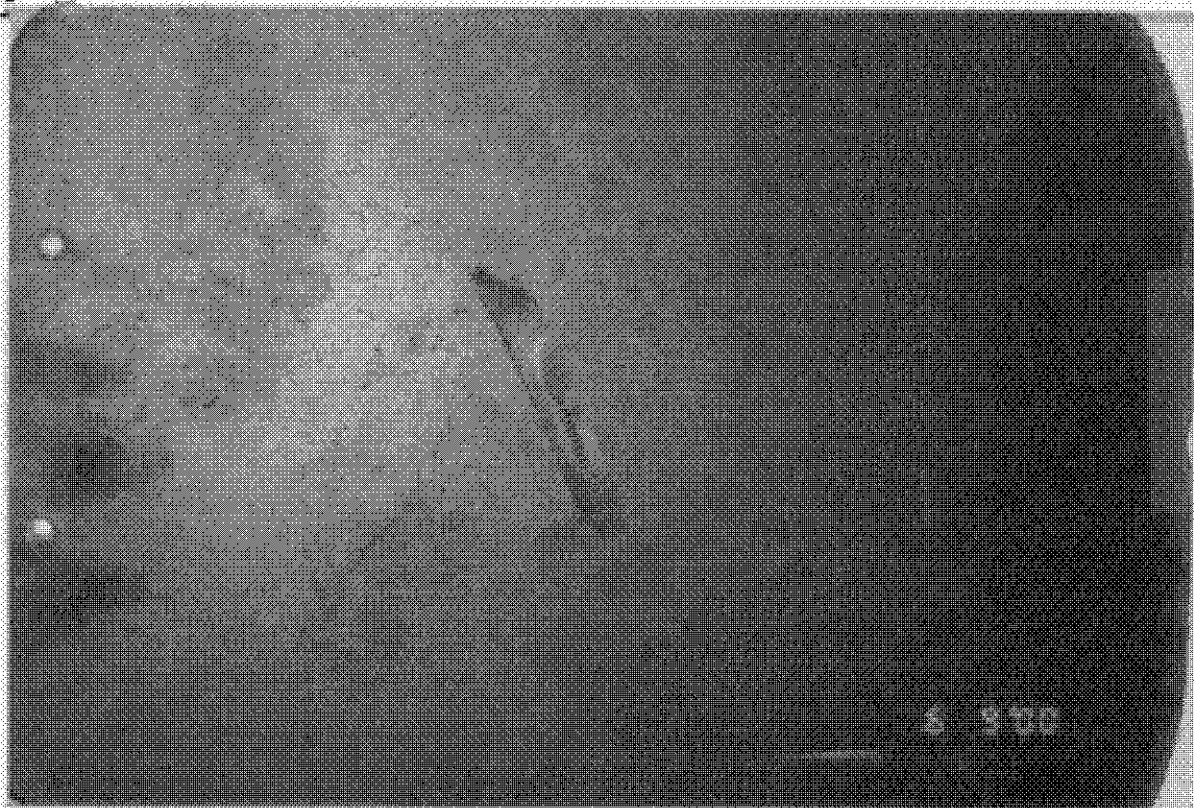
The origin of the fire was located in panels #1 and #2 somewhere behind the breakers near the top of the breaker panels. The most probable cause was a loose piece of metal banding falling onto two buss bars causing the initial arch which started a chain reaction until both generators were shut down.

EXPOSURE 29 DEPICTS 1st piece of landing found showing
signs of arcing both ends

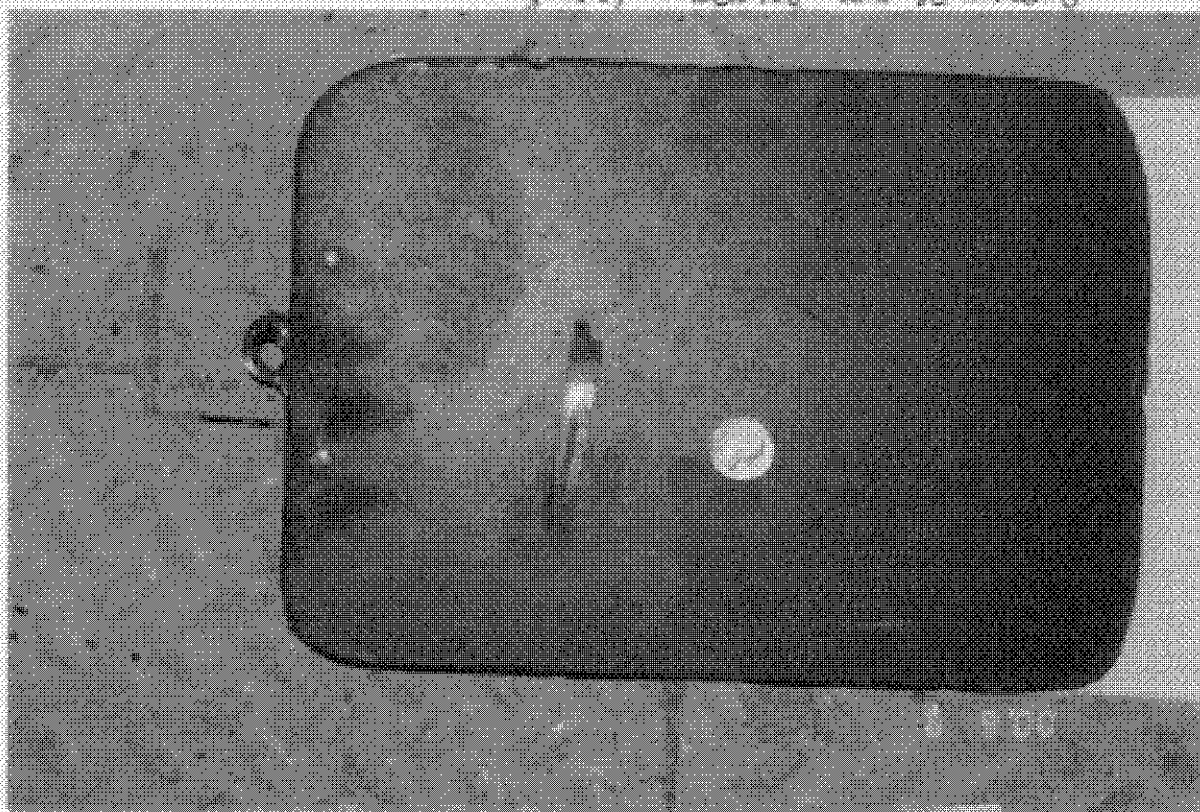
EXPOSURE 31 DEPICTS same as 29 w/ US quarter for gauge

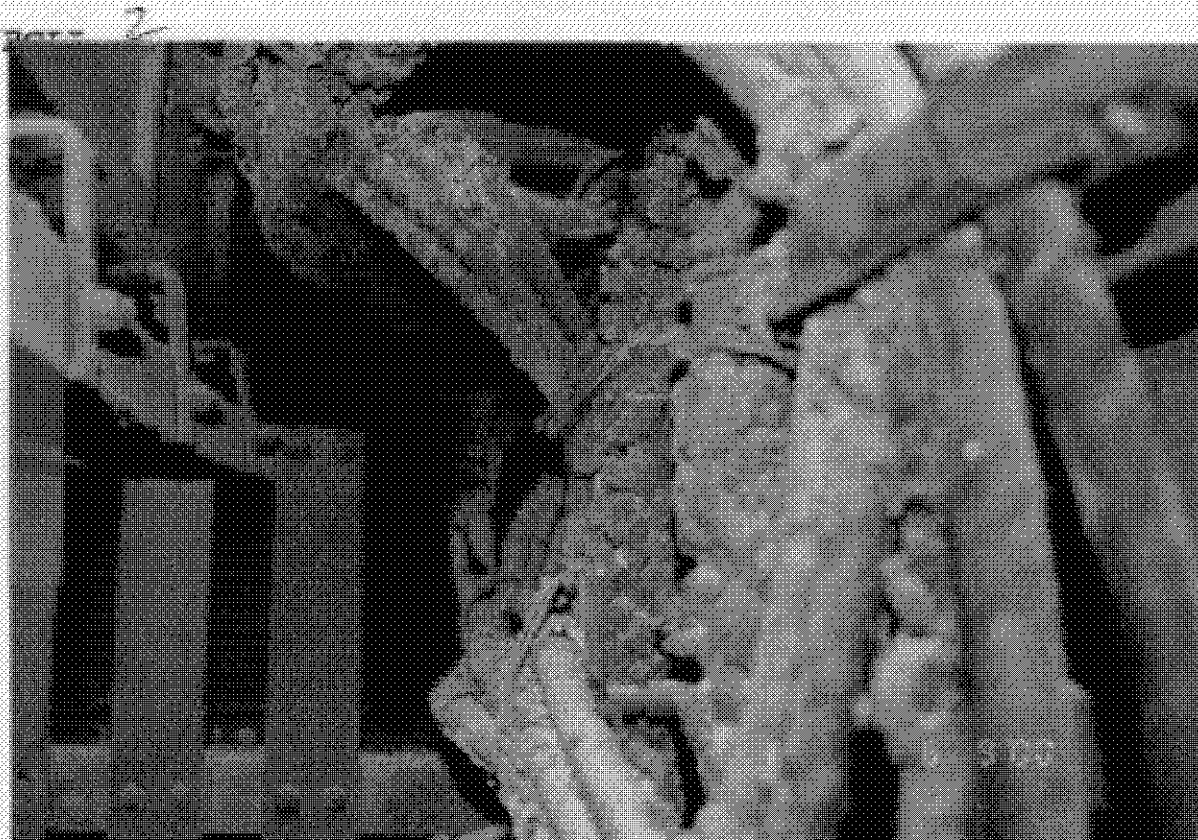
EXPOSURE 34 DEPICTS insulation on cables + banding holding cables
in bundles

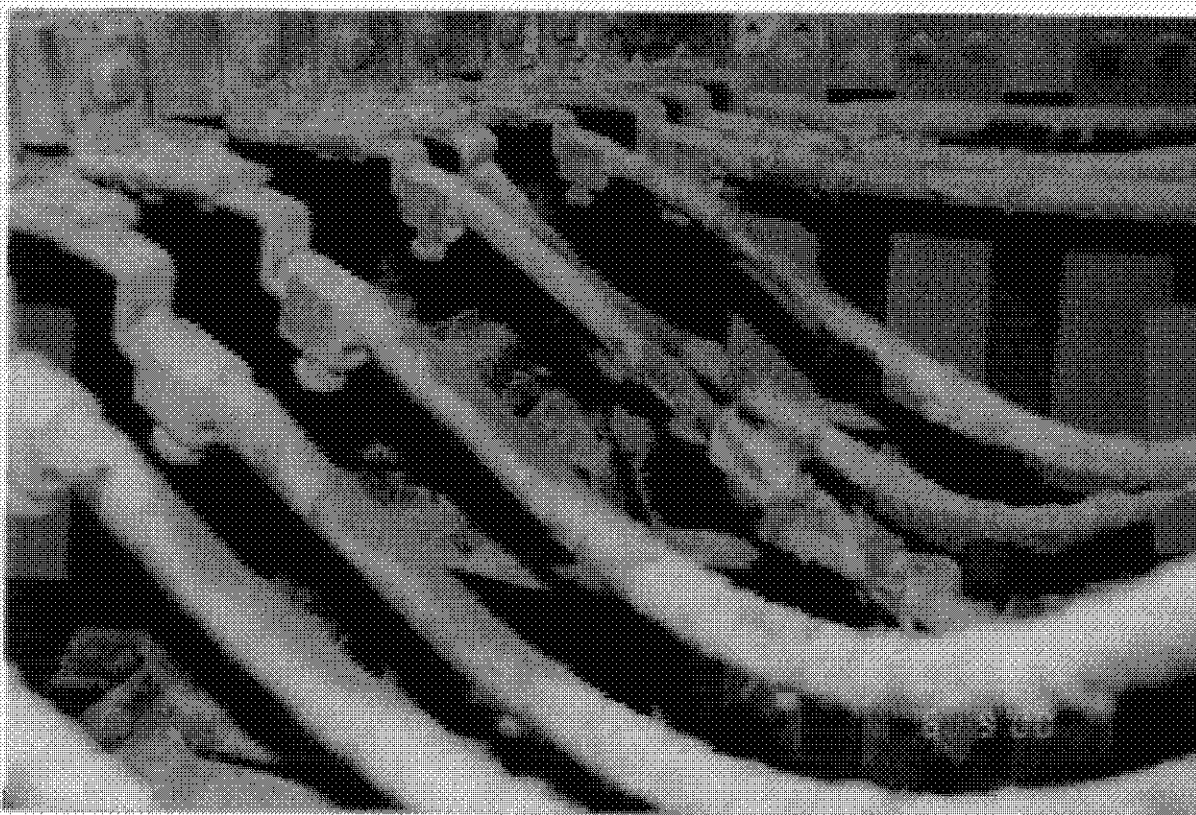
EXPOSURE 35 DEPICTS cables showing damage to insulation

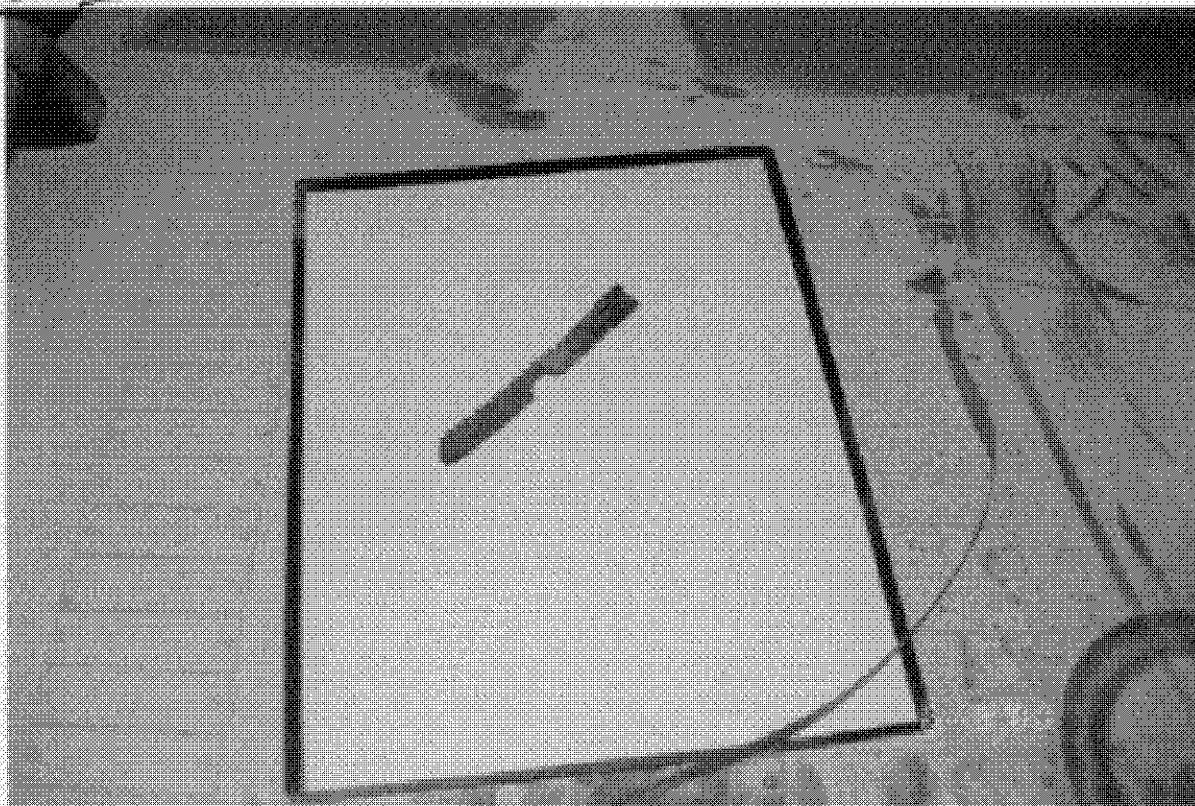
EXPOSURE E (37) DEFECTS another bonding strap showing
signs of arcing found mid/rear section of P-2

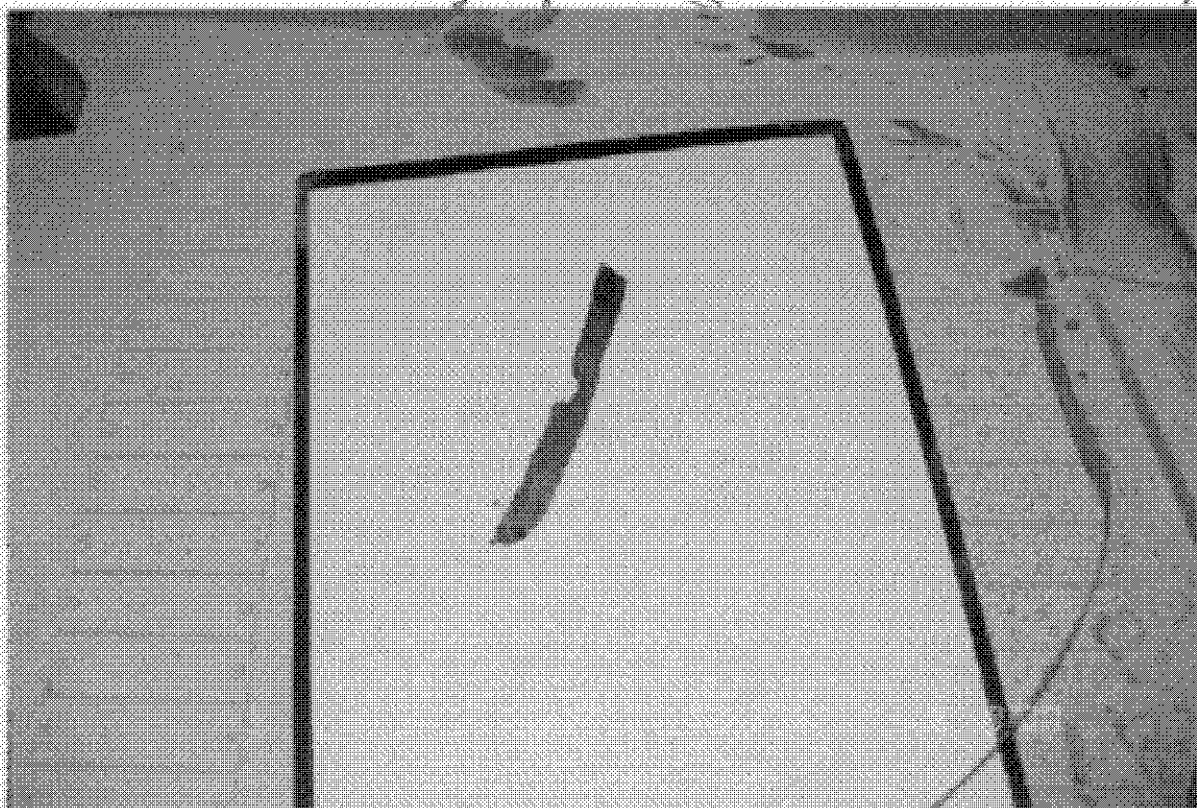
EXPOSURE 32 DEFECTS opposite side of band in above photo

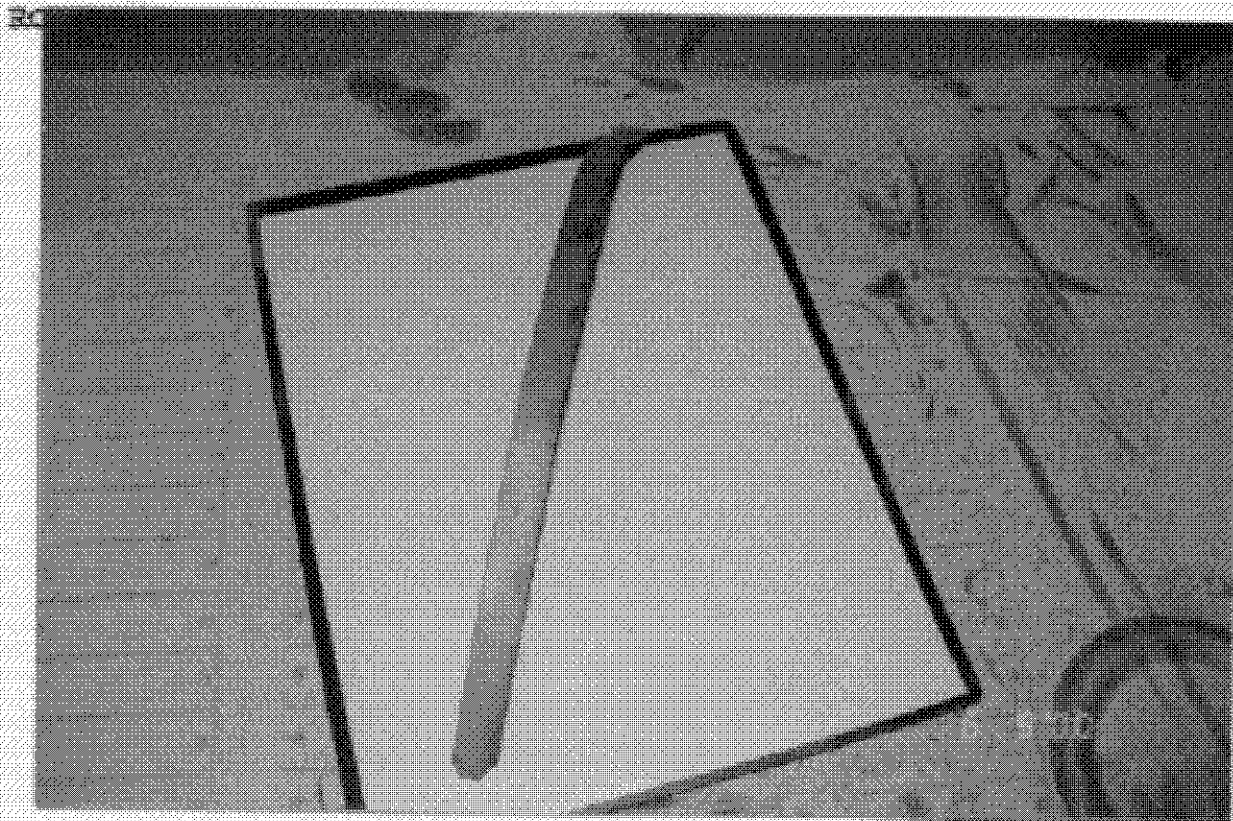
EXPOSURE 3 DEPICTS banding found (P-2 disk) No arrow

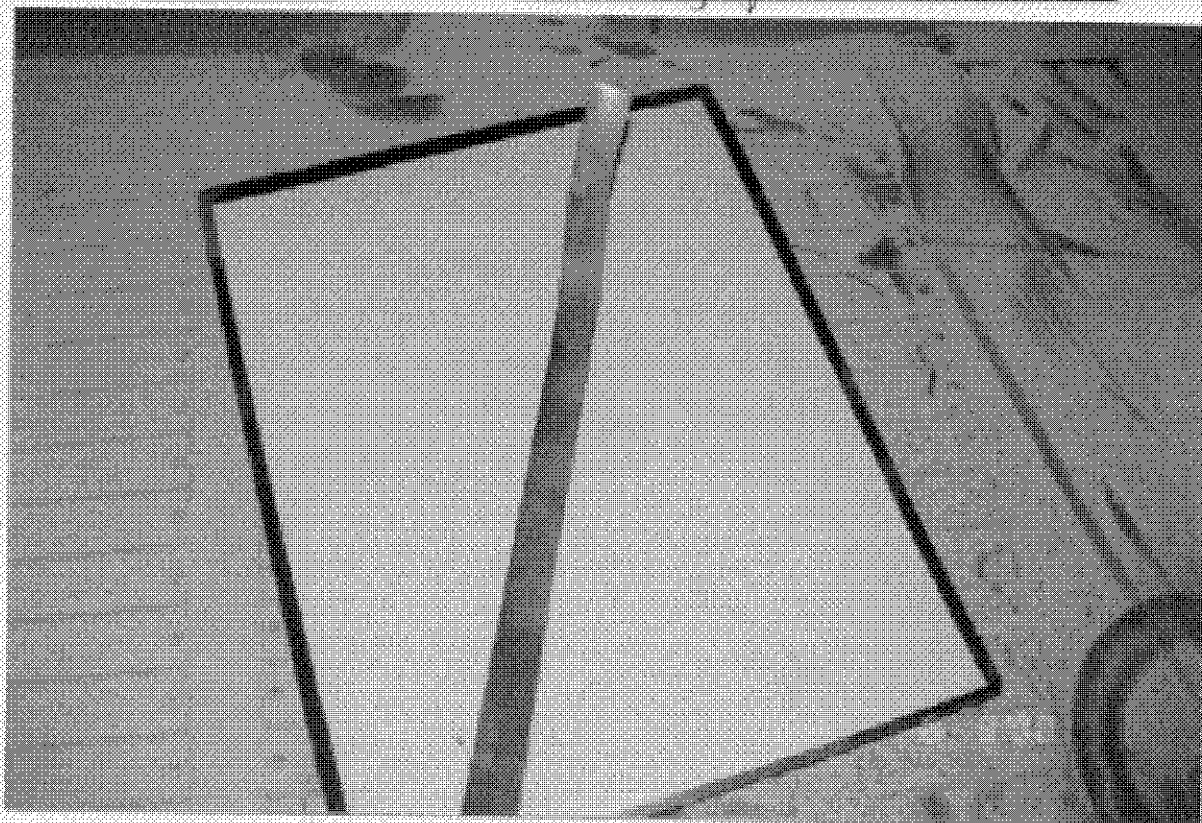
EXPOSURE 4 DEPICTS underside of above photo

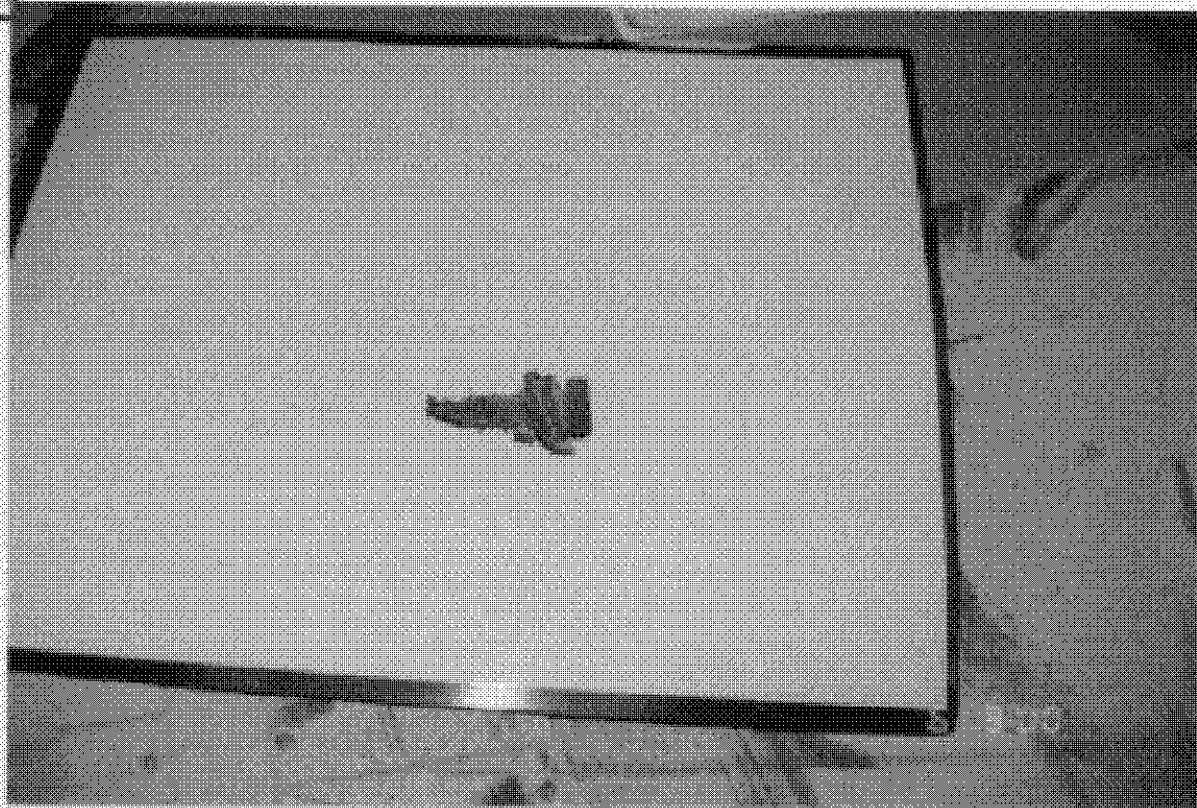
EXPOSURE 5 DEFECTS arising in load

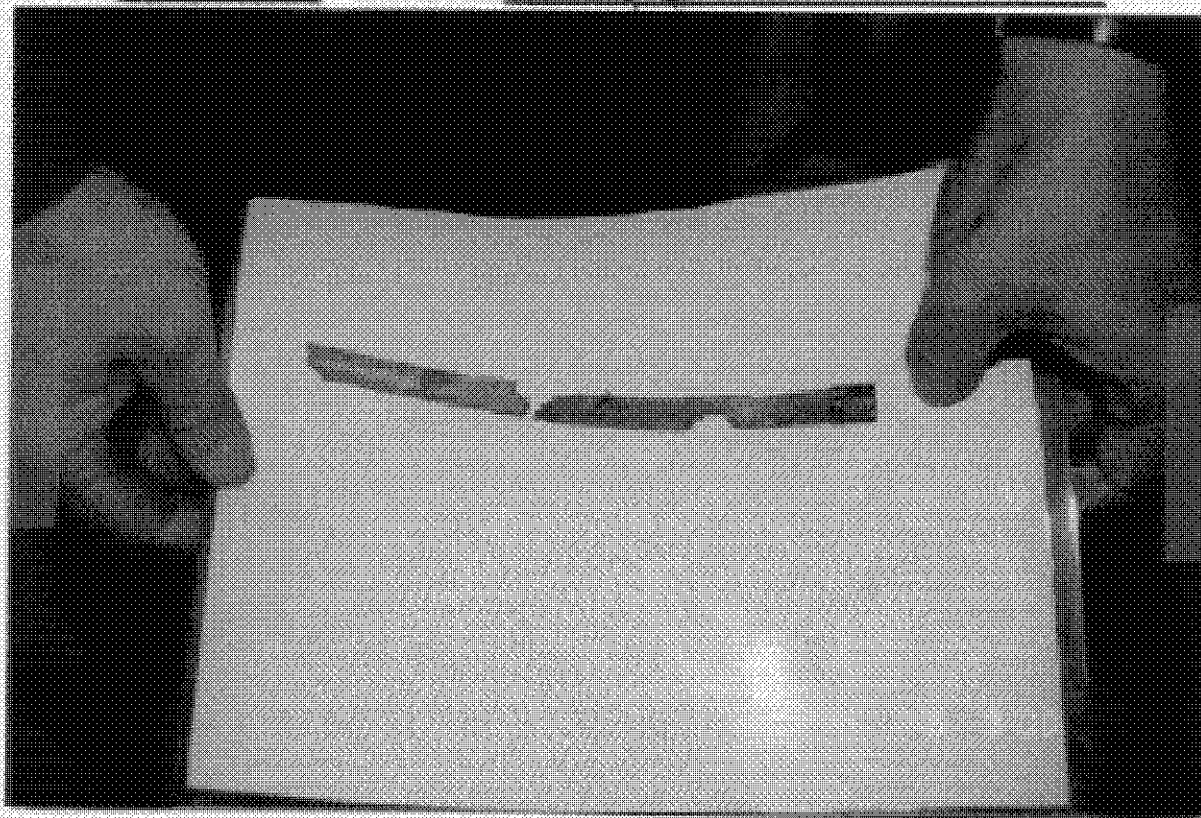
EXPOSURE 8 DEFECTS possible match of arched - banding
